Installation Instructions

S67-505

**Push Button Metering Air
Valve For 2W AST
Econowall Shower**

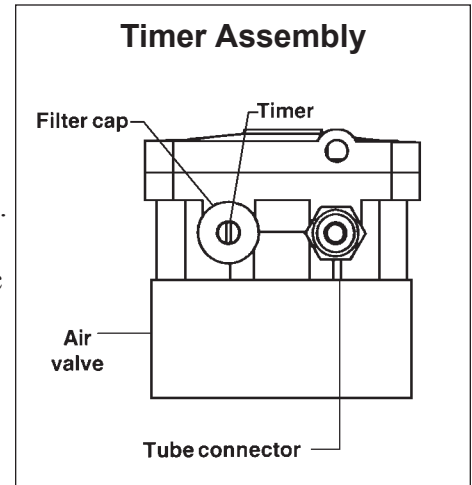
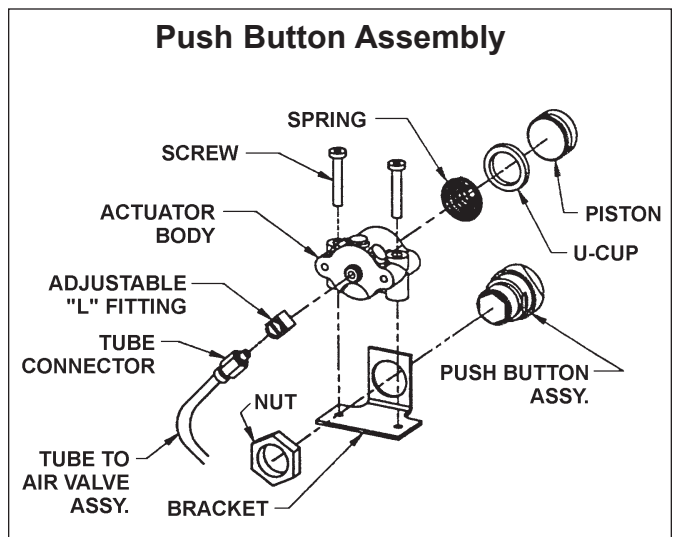
1. Check all fittings for air leaks.
2. Disassemble push button and lubricate U-cup seal (see push button assembly diagram).
