# Installation Instructions

S67-504

**Push Button Metering Air** Valve For 1WCA-ADA AST **Econowall Shower**

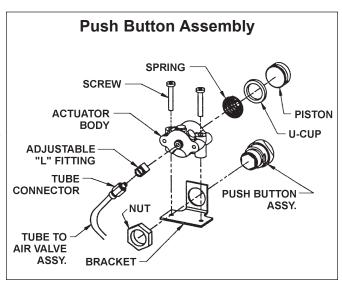
- 1. Check all fittings for air leaks.
- 2. Disassemble push button and lubricate U-cup seal (see push button assembly diagram.
