Grab Bar

$1\frac{1}{2}$ " O.D. heavy duty stainless steel grab bar with exposed mounting:

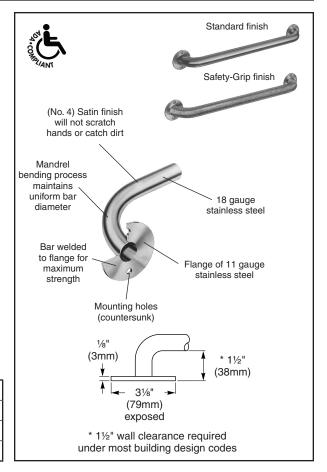
FLANGES: 3%" dia. 11 gauge stainless steel, with exposed surfaces in architectural satin finish.

TUBING: 1½" 0.D. 18 gauge stainless steel, seamless construction with exposed surfaces in architectural satin finish. Bent ends of tubing pass thru the flanges and are welded into a single structural unit for maximum strength. Intermediate supports are contour cut and joined by welding to form an integral part of the grab bar. All exposed welds ground and polished to blend. Mandrel bending process maintains uniform bar diameter. Return provides 1½" standard safety clearance between wall and bar.
